Brownfields Investments: Minimizing Risks and Maximizing Returns

Thomas Donn, P.G.

Founder and President, EnviroSouth, Inc.

Phase I Environmental Site Assessment (ESA)

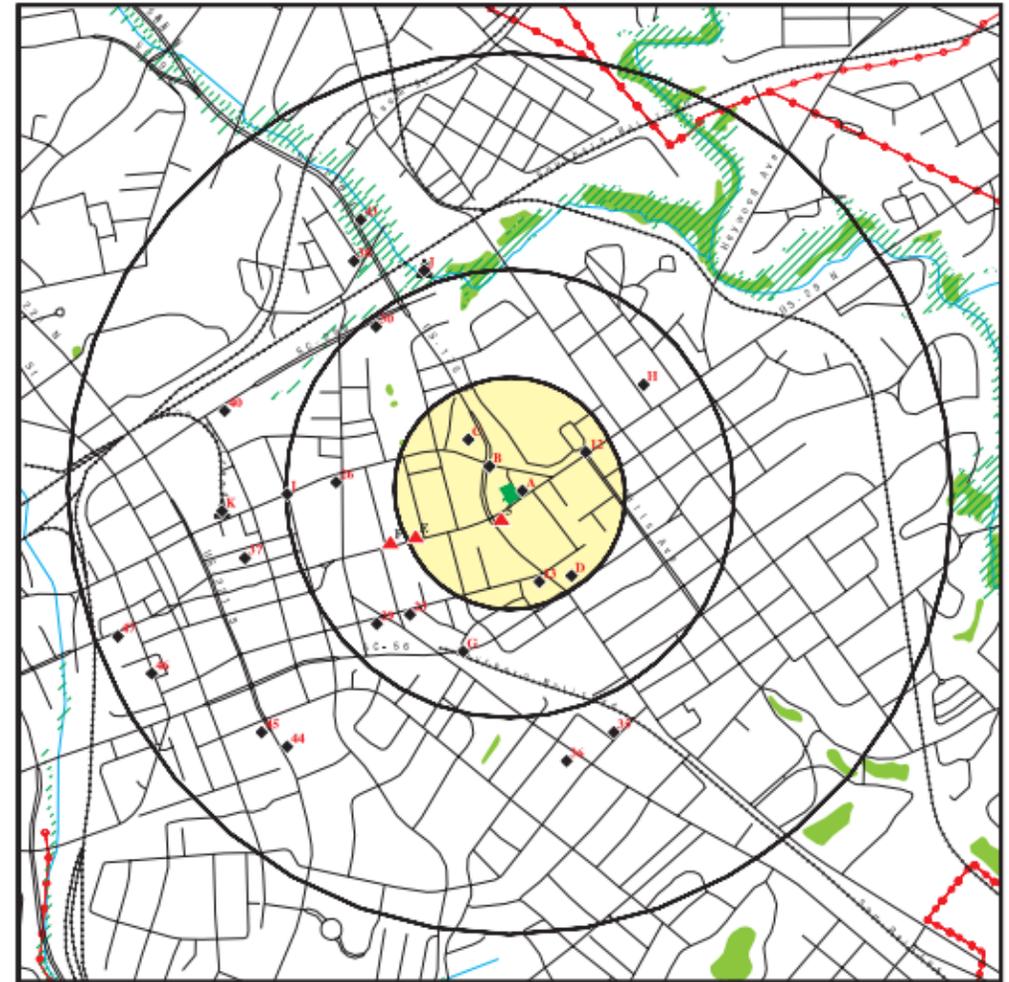
OVERVIEW MAP - 5495058.2S

- Target Property
- Sites at elevations higher than or equal to the target property
- Sites at elevations lower than the target property
- Manufactured Gas Plants
- Method Details List Sites
- Indian Reservations BIA
- Power transmission lines
- 100-year flood zone
- 500-year flood zone

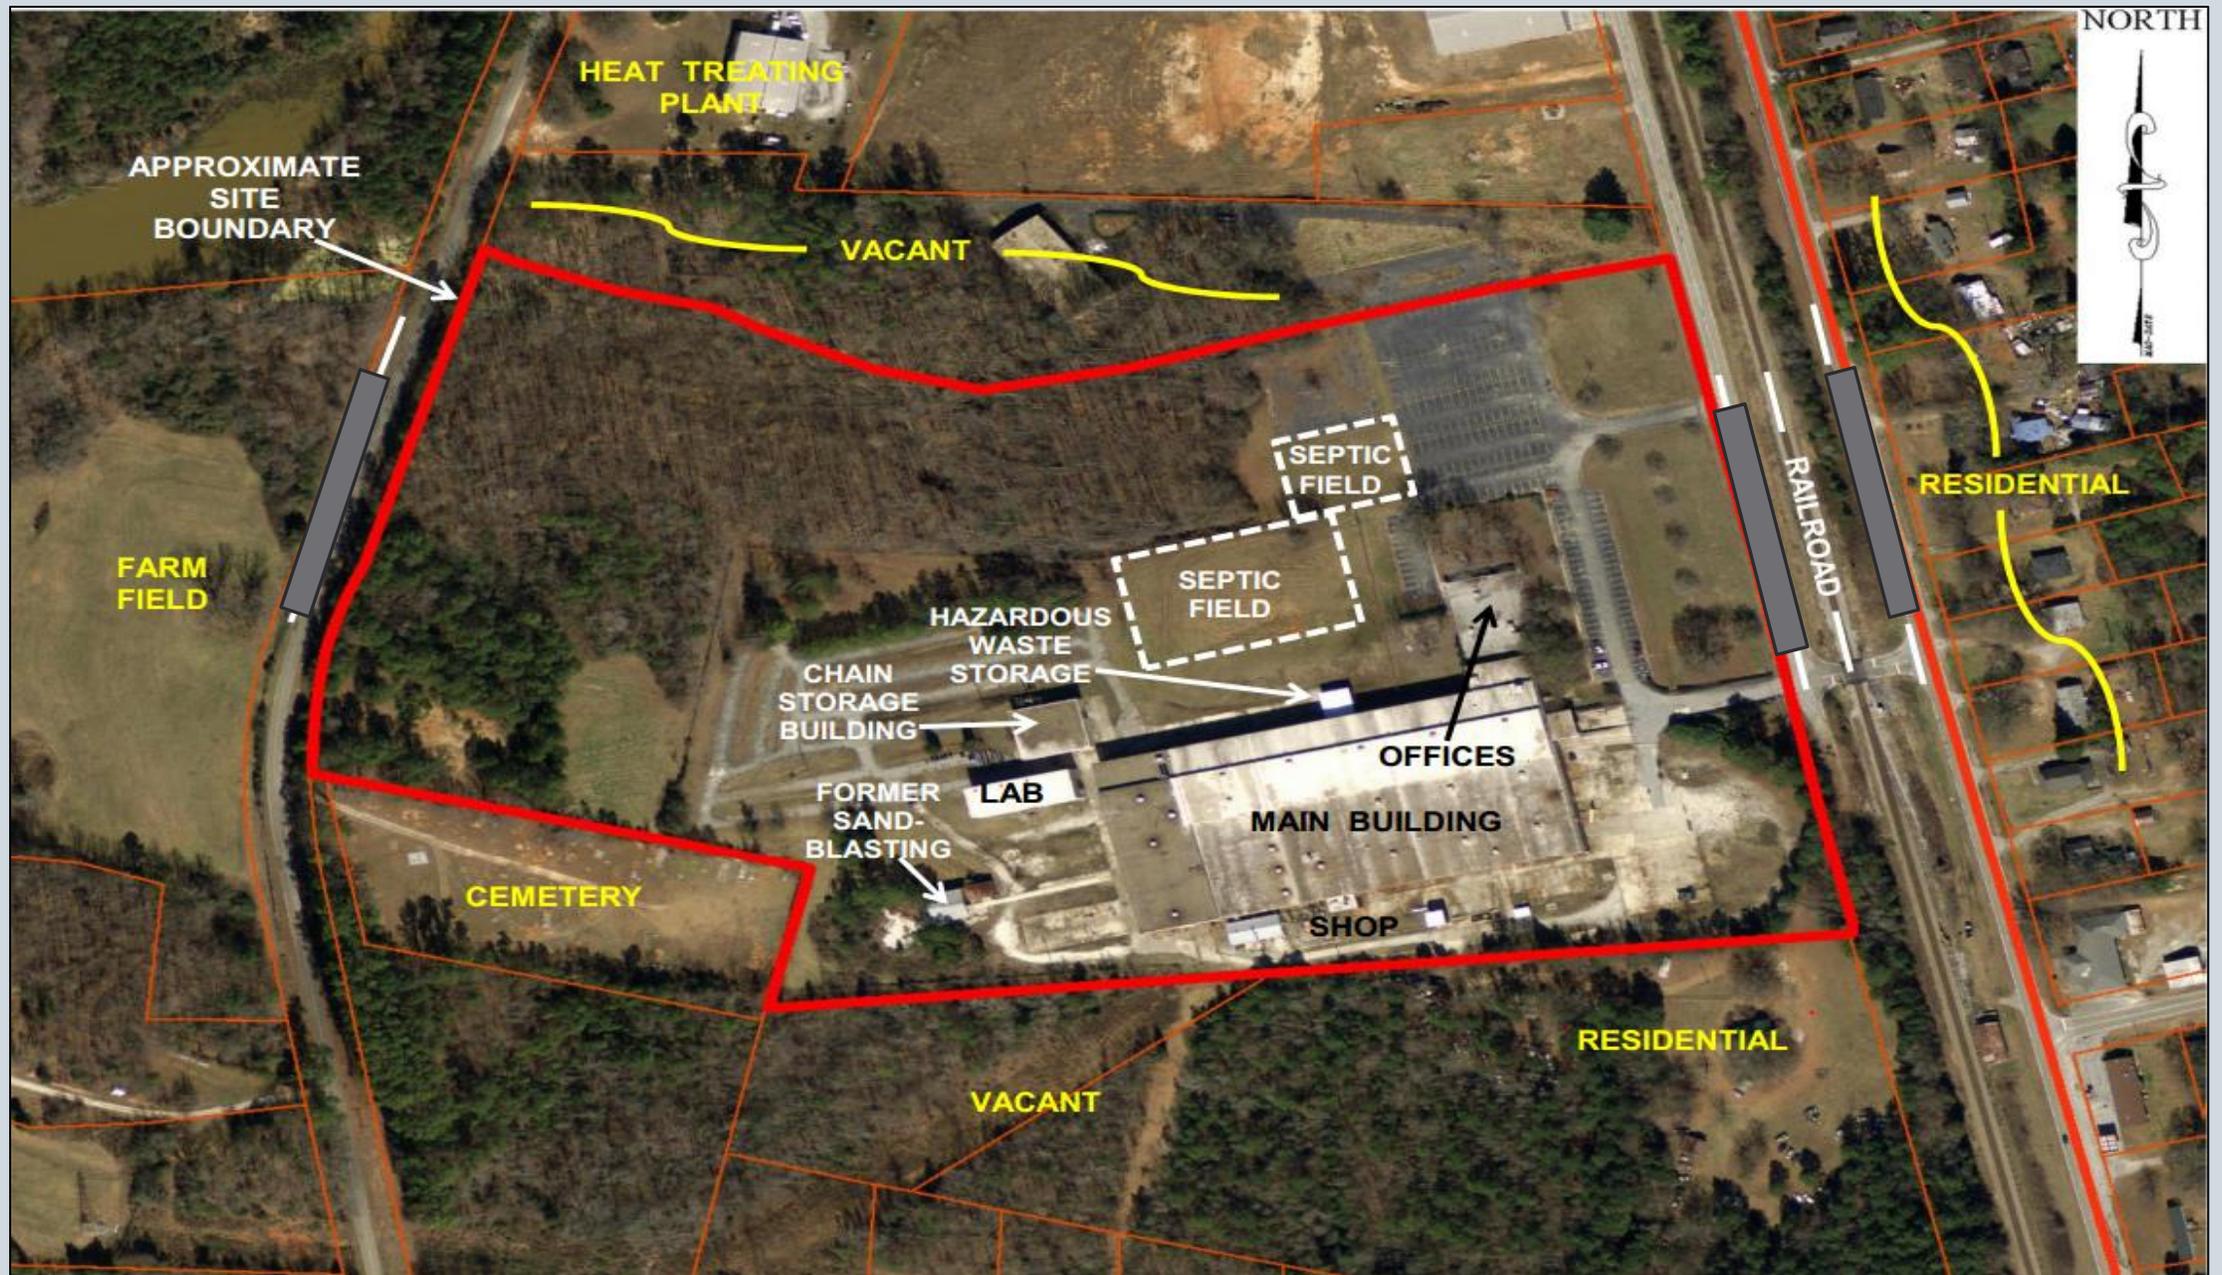
Spartanburg County, SC -- Steel Fabricating Plant from 1960 to 2014

- Upstate SC -- Steel Fabricating Plant from 1960 to 2014
- Common use of degreasing solvents (i.e. TCE) in that industry
- Septic systems as sole source of sewerage, including floor drains
- Operated a lab and reported generation of hazardous wastes
- Current owner's reps only knew chemical use history back to 2000

- Prior consultant in 2004 concluded no RECs existed
- EnviroSouth considered the likely past use of solvents combined w/septic drainfields as a REC based on likely chemical impact

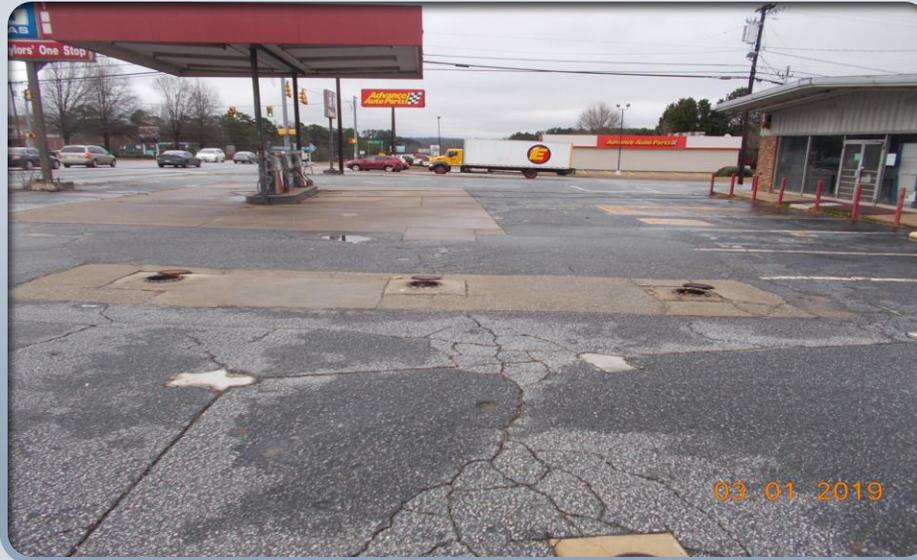
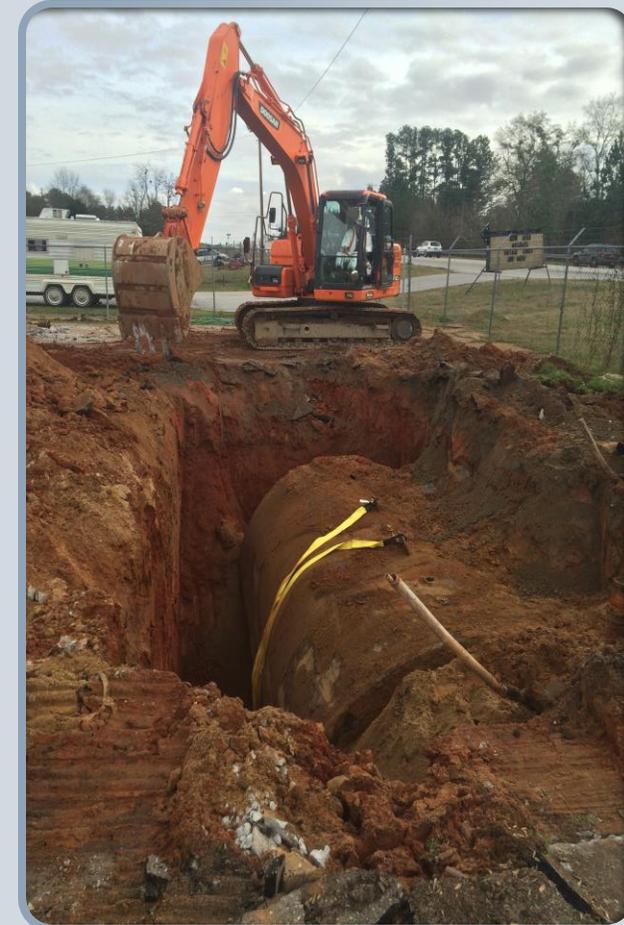
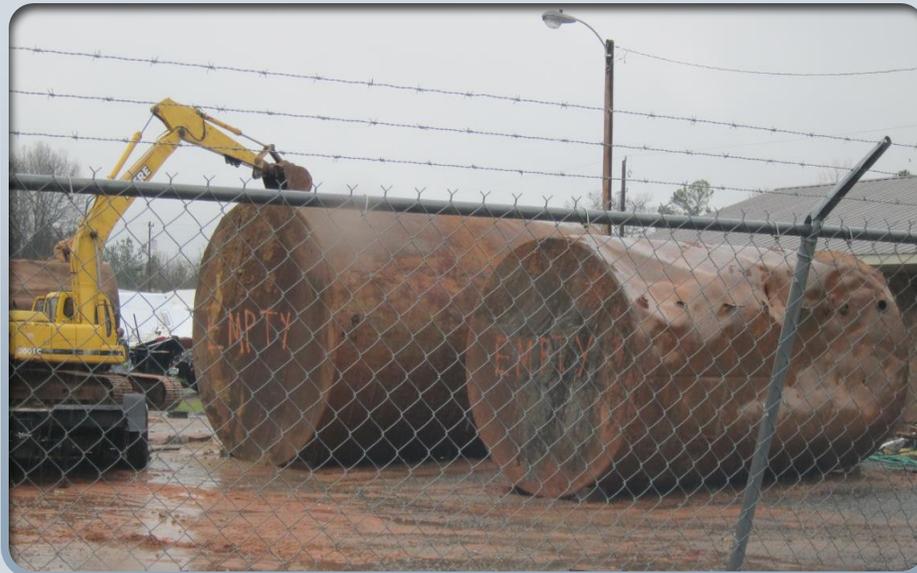
Underground Storage Tanks (USTs)

- Petroleum UST Releases are source of over 90% of groundwater contamination cases in U.S.
- South Carolina's S.U.P.E.R.B. (UST Trust) Fund -- A "safety net" for UST owners and buyers
 - Eligible ONLY for sites with USTs that store regulated fuels (excludes heating oil)
 - Funding (½ cent per gallon tax; UST annual fee)
 - \$25,000 deductible
 - UST owner at time of discovery is the Responsible Party (RP)
 - "Orphan" site if USTs abandoned and no RP exists

- Rules for Installation, Operating, and Abandonment
- Must be abandoned by Removal or Filling-In-Place
- Annual Fees (per tank per year; approx. \$7,000 per UST since 1988)
- Releases (spill or leaks) are SUPERB eligible

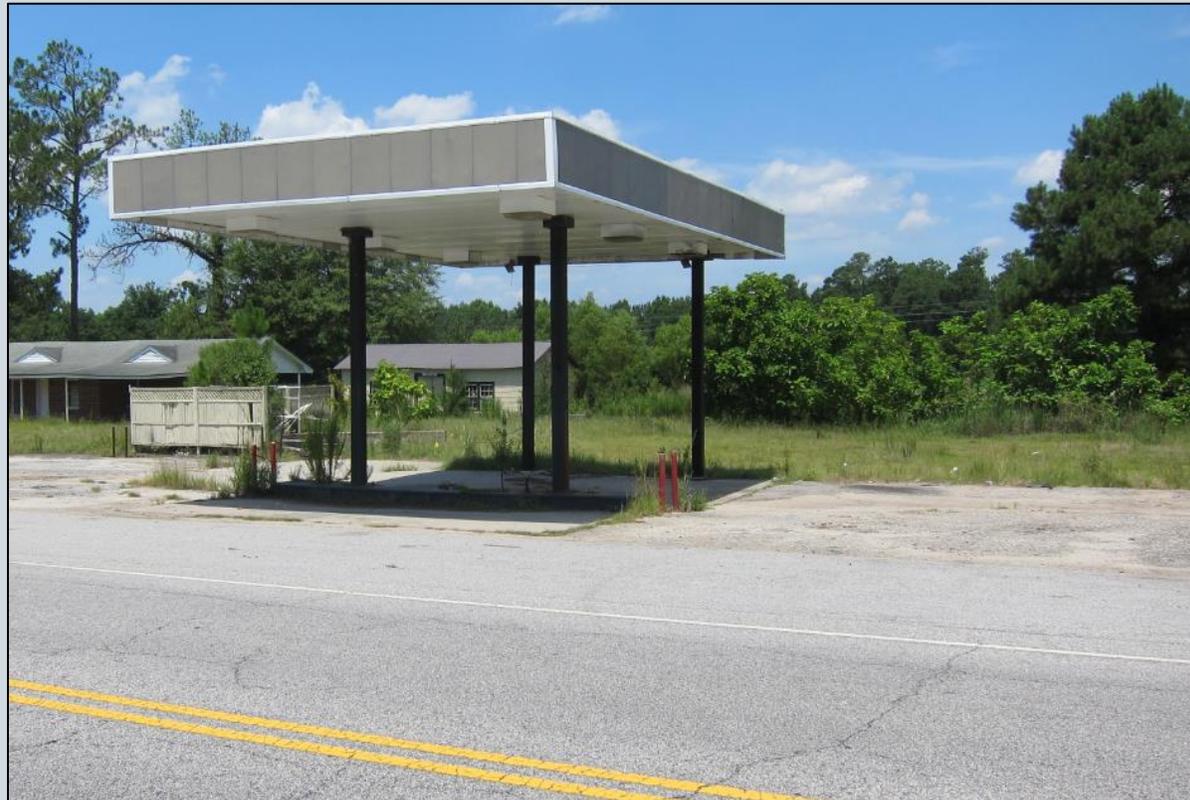
Phase II ESA – Case Study

Groundwater Impact at UST/AST facility, Florence County, SC

- Phase I ESA for Buyer
- Phase II found dissolved gasoline in GW
- Not eligible for SUPERB Fund because clean UST closure, then ASTs used with U/G pipes
- Price reduced by \$50,000 for delays and VCC costs

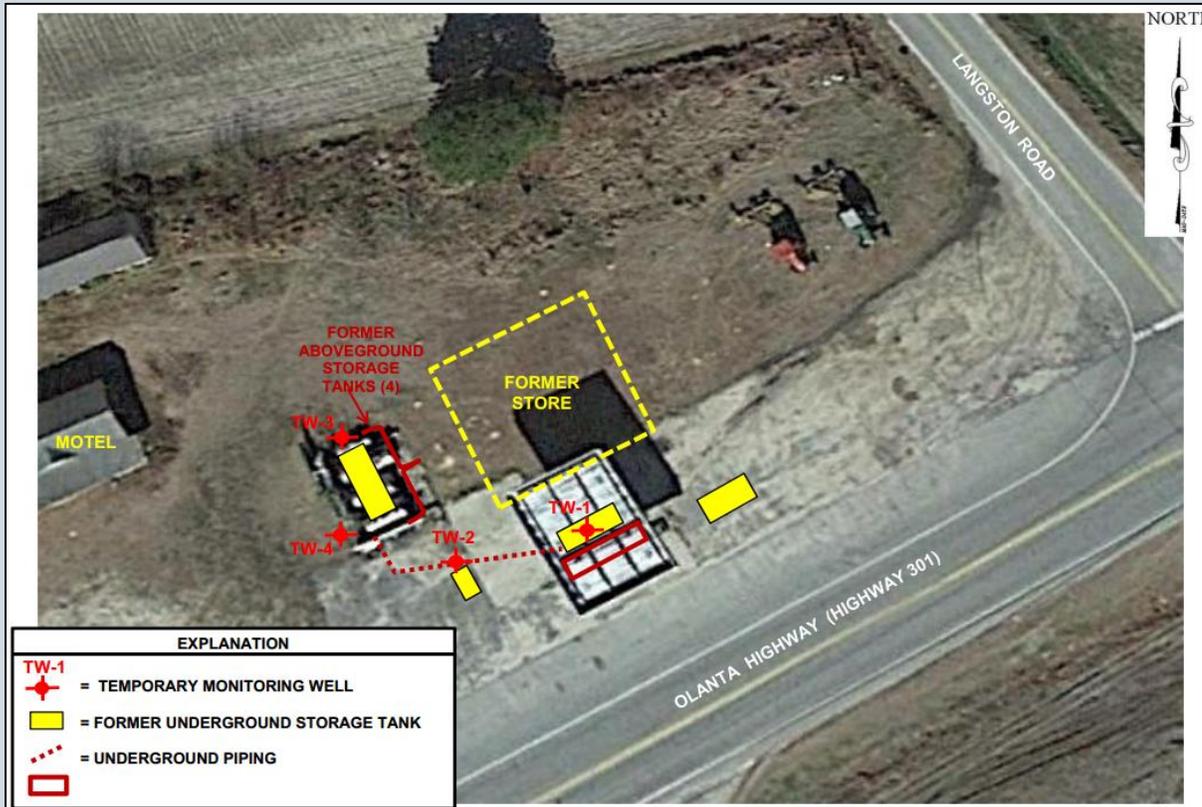
Groundwater Impact at UST/AST facility, Florence County, SC

- USTs Closed by Owner
- "Clean" Closure
- NFA Letter from SCDHEC
- Aboveground Fuel Tanks (ASTs) installed

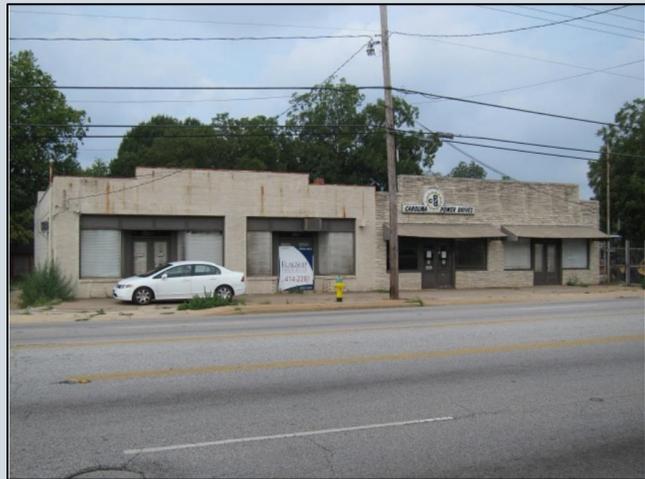
Former Dry Cleaning Facility, Greenville, SC

City Directories: On-site drycleaner
from 1935 to 1970

Type of DC solvent unknown; Perc
use was widespread beginning in 1940s

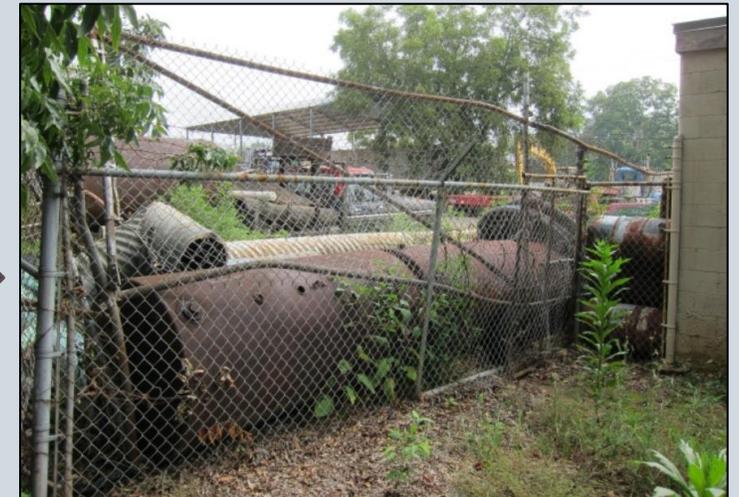
Petroleum Tanks and Chemical
Drums located off-site at property
line

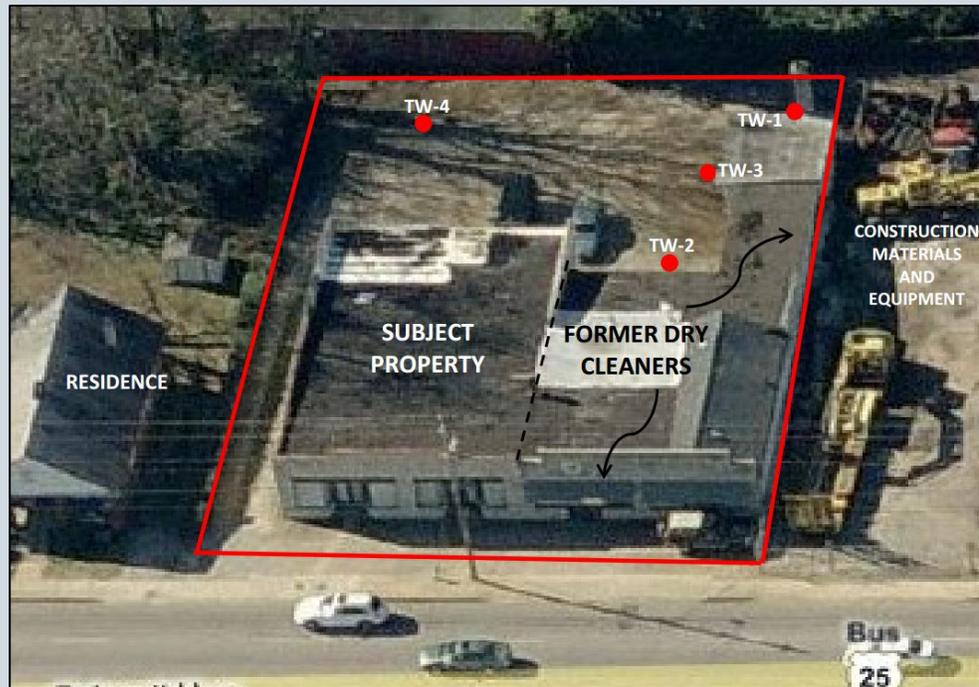
Former Dry Cleaning Facility, Greenville, SC

4 Groundwater samples collected

Analyzed in lab for VOCs

VOCs include many petroleum compounds and the main chlorinated dry cleaning solvent Perc (PCE or tetrachloroethene)

No VOCs found in groundwater

Concluded that the DC likely used petroleum-based solvents
